**HIGHWAY
RESEARCH**

341

Aggregates and
Skid Resistance of
Bituminous Pavements

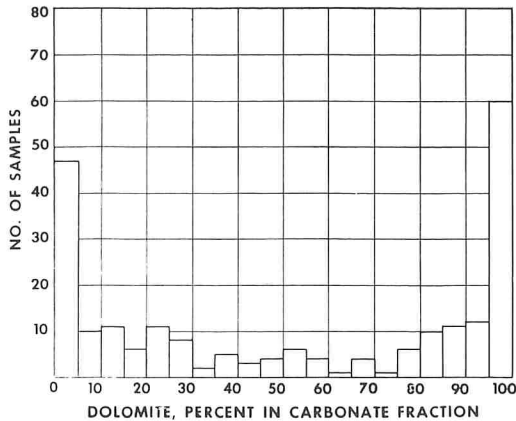
Figure 2. Distribution of carbonate compositions of 224 test samples.

to Mississippian. Figures 2 and 3 show the general composition of carbonate aggregates quarried in the state (10). Individual rock samples tend to be either predominantly calcite or predominantly dolomite rather than mixtures of the 2 minerals (Fig. 2). For example, of the 224 samples processed, 47 were predominantly calcite and contained less than 5 percent dolomite, while 60 were predominantly dolomite and contained less than 5 percent calcite. The range of insoluble residues for the same group of 224 samples is shown in Figure 3. Clearly, limestone aggregates produced in Virginia tend to contain low percentages of insolubles, with more than 50 percent of the samples falling in the interval between 0 and 10 percent. On the other hand, the 3 highly impure limestones considered by Gray and Renninger (4) as having excellent skid-resistance properties contained from 36 to 48 percent insolubles. It would appear that these kinds of rocks are typical of the vast majority of Virginia limestone aggregates (Fig. 3).

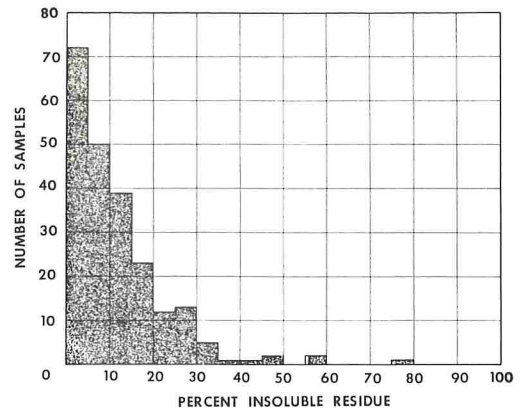
Figure 3. Distribution of insoluble residues determined for 224 test samples.

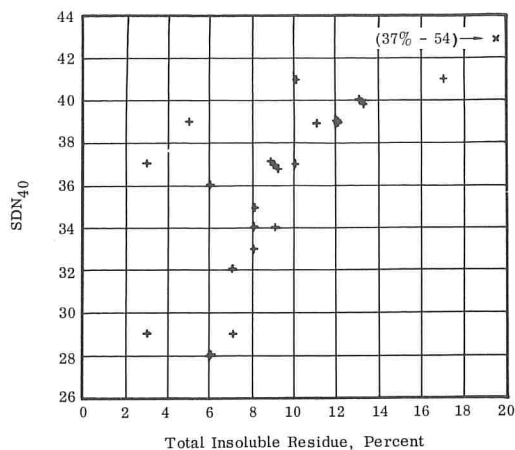
Figure 4. Effect of insoluble residue on polish resistance.

of this relationship, Figure 4 was constructed by plotting coefficient of friction versus insoluble residue for each quarry source. A fairly well-defined curvilinear relationship, similar to that obtained by Burnett et al. (1) for insolubles coarser than 200 mesh, is evident. It is thought that more detailed sampling and insoluble residue measurement for these and other limestone sources will clarify this relationship.

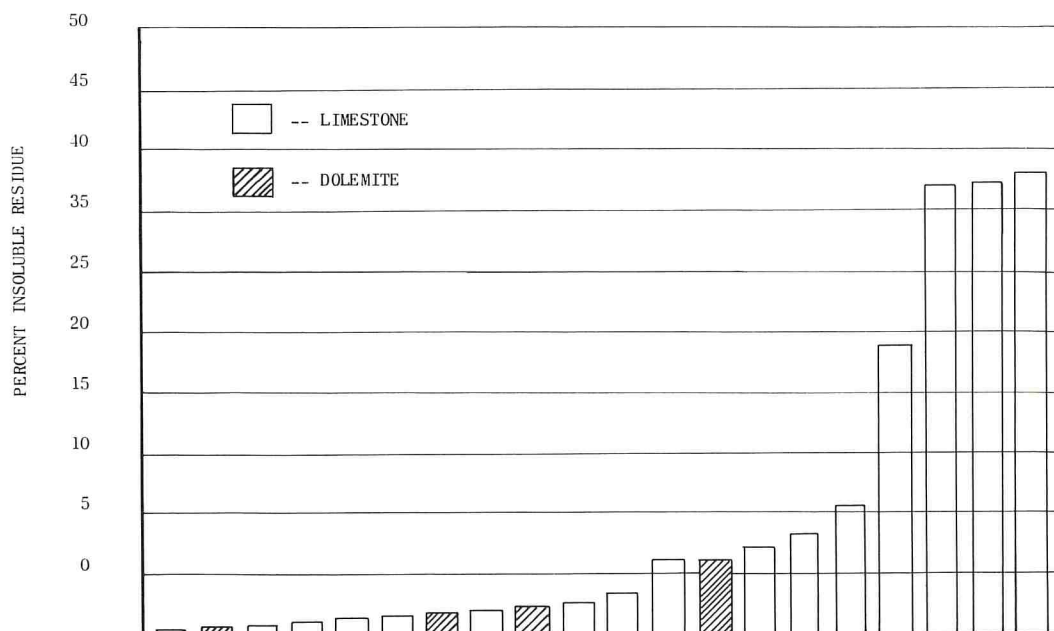
Figure 2. Percentage of insoluble residue of +200 sieve size on test strips 1 through 11.

Insoluble residue tests were run on a cross section of carbonate aggregates produced from rock from various geologic areas in Pennsylvania. This permitted a selection of 20 carbonate aggregates, including limestones and dolomites with insoluble residues ranging from less than 1 percent to more than 35 percent as shown in Figure 2.

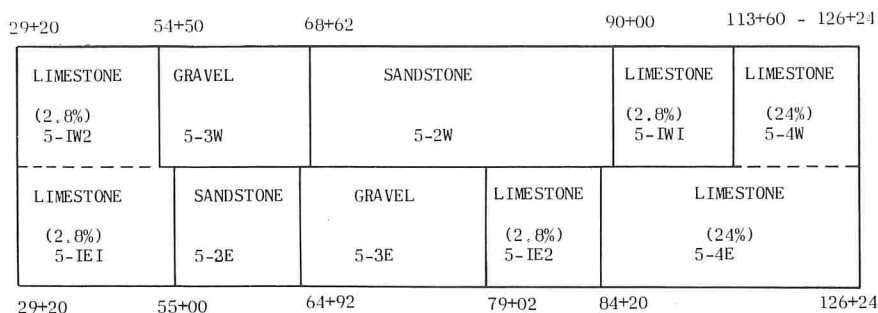
Figure 3. Plan of test strip 5.

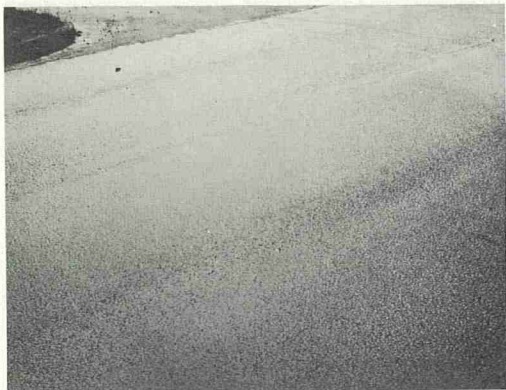
Figure 1. Slippery pavement surface of polished limestone.

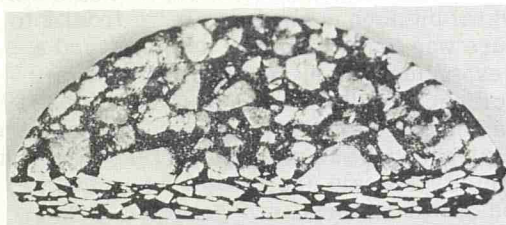
Figure 3. Pavement core showing aggregate particles in oily polished surface.

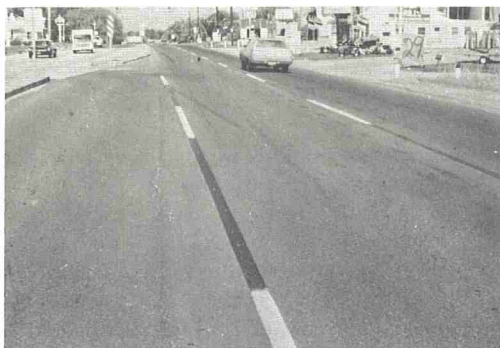
Figure 4. Crushed sandstone surface 4 years after construction.

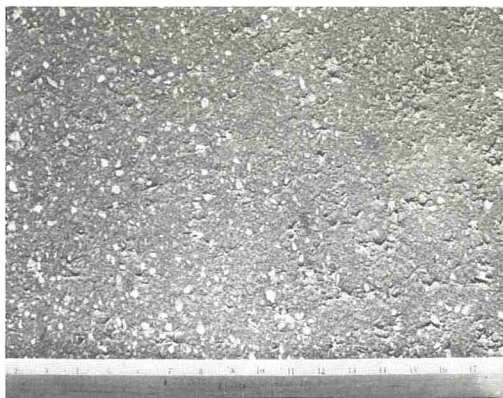
Figure 5. Close-up of sandstone surface 4 years after construction.

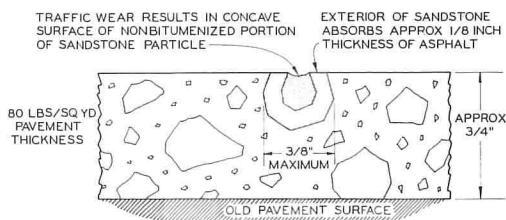
Figure 6. Result of traffic wear on larger particles of crushed sandstone.

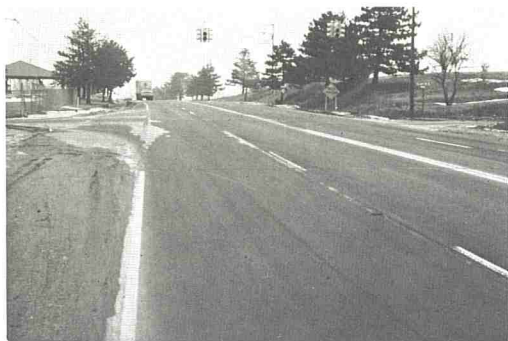
Figure 7. Crushed quartzite surface 3 years after construction.

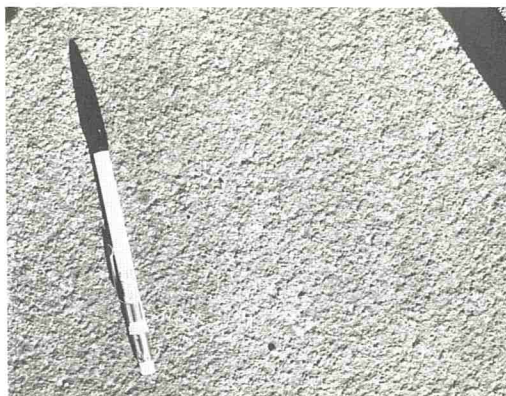
Figure 8. Close-up of quartzite surface 4 years after construction.

percent 60 to 70 asphalt; 4.0 percent fly ash was added as mineral filler to make up for the fines lost through washing, and the remainder was quartzite crushings. No other aggregate was added for this mix design. Figure 7 shows a typical surface after 3 years of service in the Flint area. Some loss was experienced where traffic entered from a side gravel road causing considerable localized abrasion; however, the rest of the surface is in good condition. Figure 8 shows a close-up of this excellent skid-resistant surface.

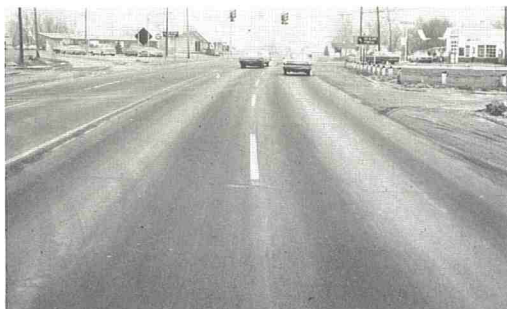
Figure 9. Crushed beach pebbles 3 years after construction.

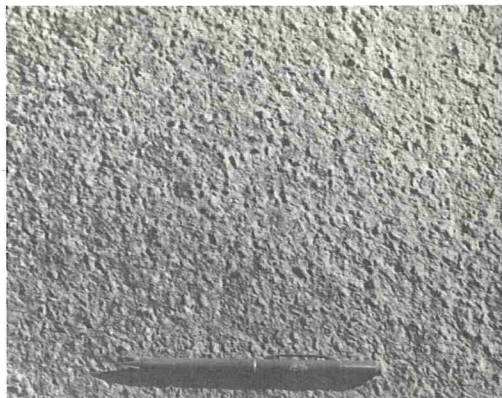
Figure 10. Close-up of beach-pebble surface 4 years after construction.

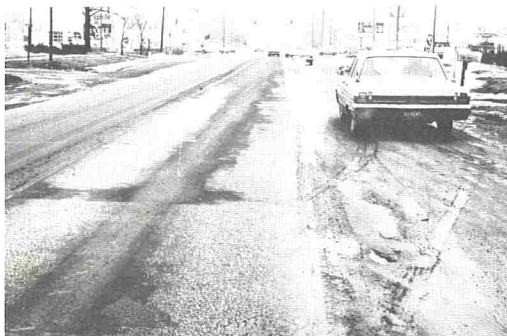
Figure 11. Crushed traprock 3 years after construction.

The mix design called for 6.1 percent 60 to 70 asphalt plus 3.5 percent added fly ash mineral filler; the remainder was crushed traprock. No other aggregate was added to this mixture, which was used at an intersection south of Flint. Figure 11 shows the

surface after 3 years of service. Considerable areas of the surface were worn completely through to the old pavement. No detour provisions were made, and heavy traffic was permitted to traverse the uncured, warm mat, resulting in premature wear that was evident within a few days after construction. I believe this mix would have proved more durable if traffic had not been permitted on the warm surface during construction.

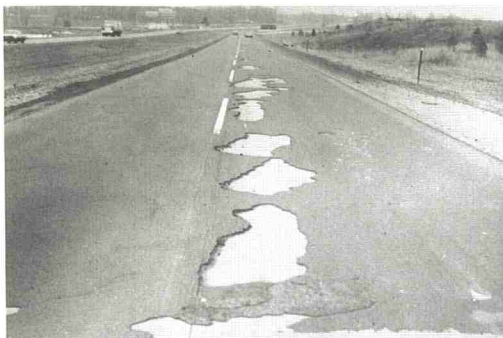
Figure 12. Synthetic bitumen and sand 1 year after construction.

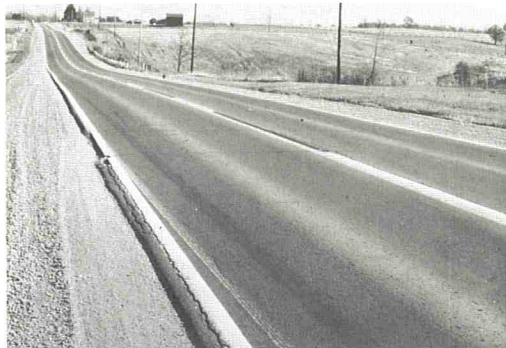
Figure 13. Sand-emulsion surface 4 years after construction.

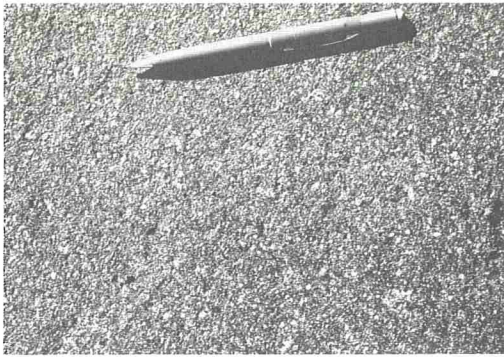
Figure 14. Close-up of sand-emulsion surface 4 years after construction.

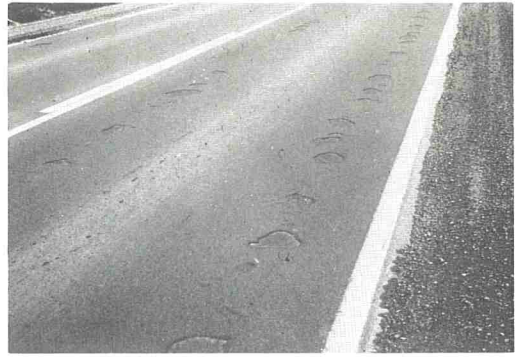
Figure 15. Delamination of sand-asphalt surface 1 year after construction.

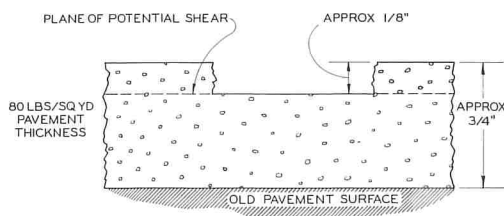
Figure 16. Cross section of delaminated sand-asphalt surface.

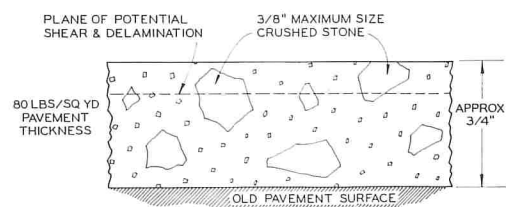
Figure 17. Cross section of stone-filled sand-asphalt surface.

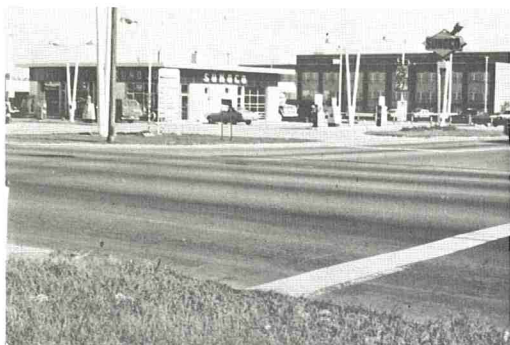
Figure 18. Stone-filled sand-asphalt surface 4 years after construction.

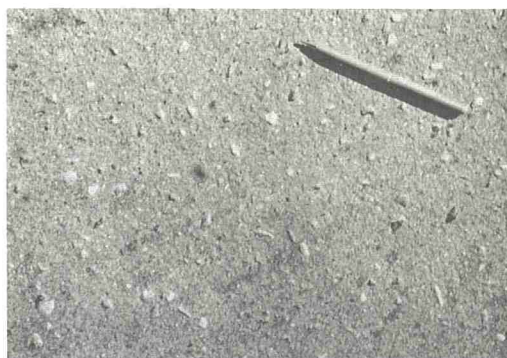
Figure 19. Close-up showing stones sticking out of stone-filled sand asphalt.

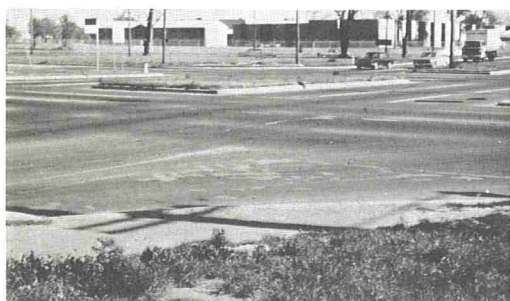
Figure 20. Raveled fillets of sand-asbestos surface 4 years after construction.

Figure 20 shows a typical area in Detroit after 4 years of service. It is generally in good condition except for the fillet areas that were manually placed and cooled before

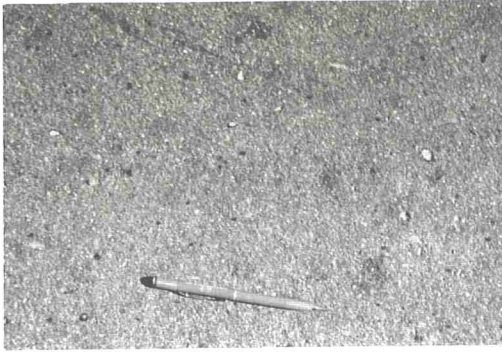
Figure 21. Close-up of sand-asbestos surface 4 years after construction.

they were properly compacted, resulting in some raveling. Figure 21 shows a close-up of the sand-asbestos-asphalt surface texture that exhibits satisfactory skid resistance.

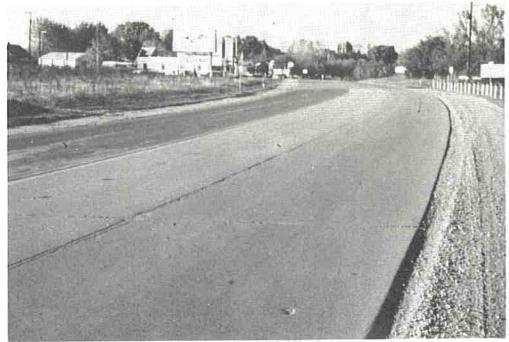
Figure 22. Sinopal-sand surface 4 years after construction.

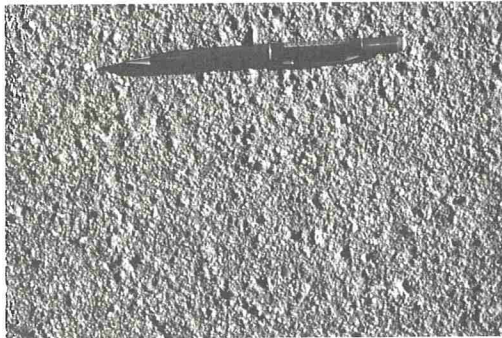
Figure 23. Close-up of Sinopal-sand surface 4 years after construction.

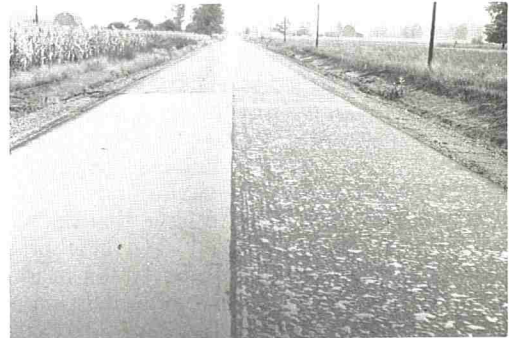
Figure 24. Freshly laid bituminous surface after rain.

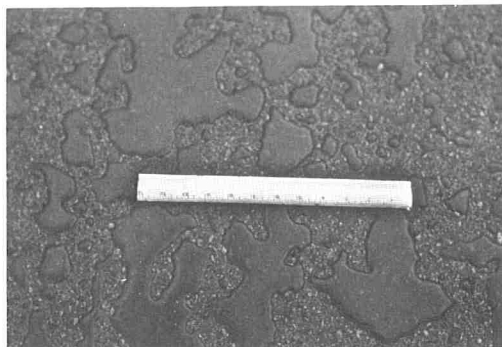
Figure 25. Close-up of fresh, oily, nonwetting bituminous surface after rain.

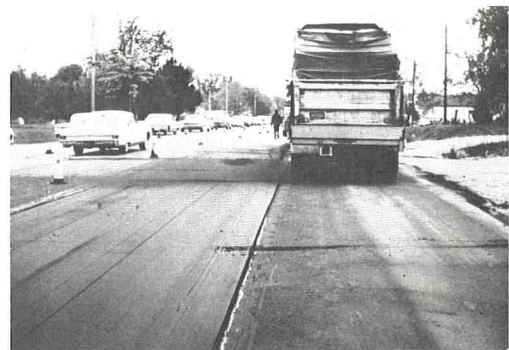
Figure 26. Spreading precoated sand on unrolled bituminous mat.

initial skid-resistant bituminous surface by applying hot sand, precoated with about 1 percent asphalt cement, on the unrolled mat behind the paver. This is then rolled into the surface and reduces the initial slickness. About 2 to 5 lb/sq yd of this precoated sand is sufficient; more may produce a ball-bearing effect, which can also be dangerous and may mar the pavement surface when bunched-up sand is rolled into the mat.

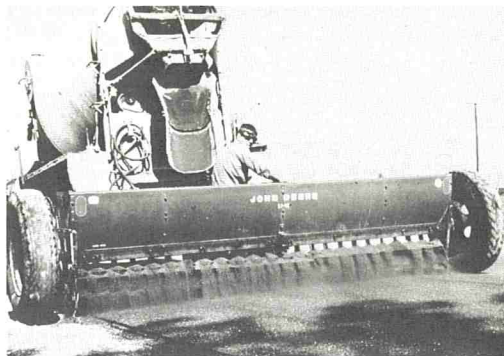
Figure 28. Seeder used for spreading precoated sand leaves ridges.

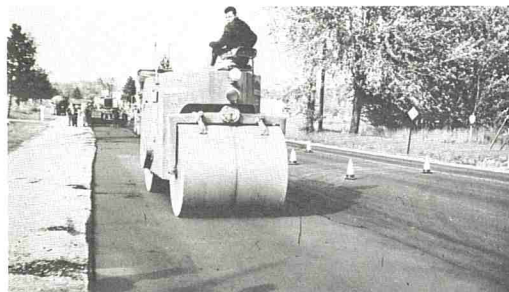
Figure 29. Rolling pavement after sand application.

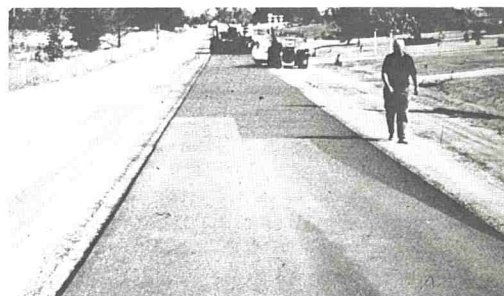
Figure 30. Precoated sand on mat of partly rolled surface.

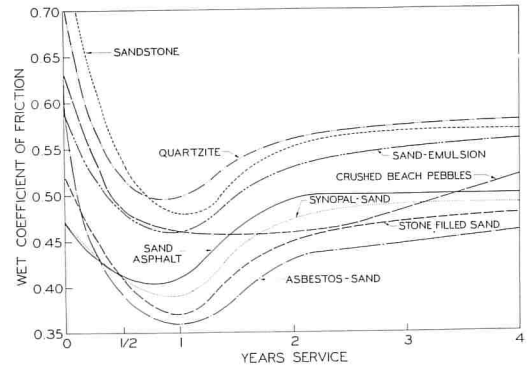
Figure 31. Pavement skid-resistance coefficients of different materials versus years of service.

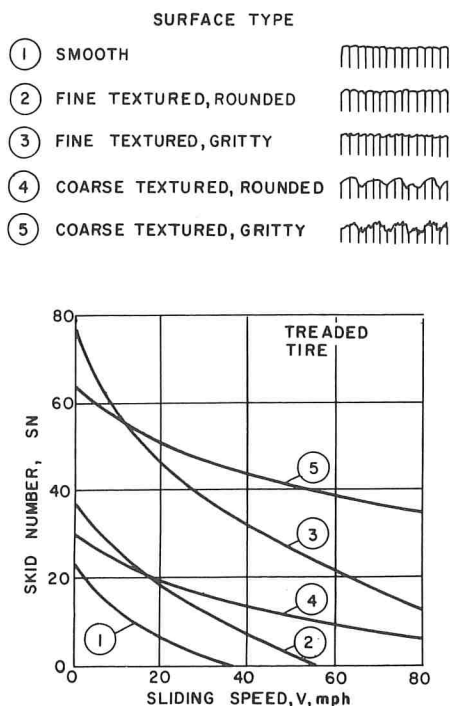
Figure 1. Classification of pavement surfaces according to their friction and drainage properties (13).

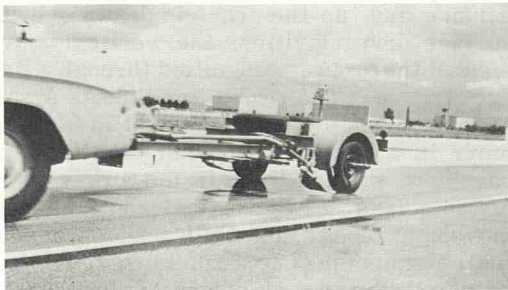
Figure 2. Texas Highway Department research skid trailer.

The friction measurements reported here were obtained with the Texas Highway Department research skid trailer that conforms substantially to ASTM standards and utilizes E-17 treaded tires inflated to 24 psi. The drag forces were measured with strain gages, and the self-watering system utilized a centrifugal pump that applied a water film approximately 0.020 in. in thickness to the pavement surface. The development and calibration of the trailer may be reviewed in an earlier research report (14). Figure 2 shows the trailer under test conditions.

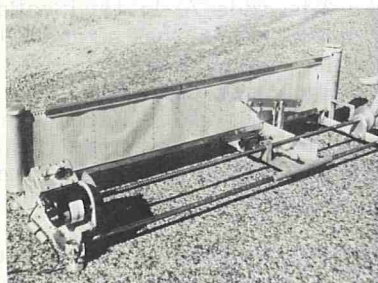
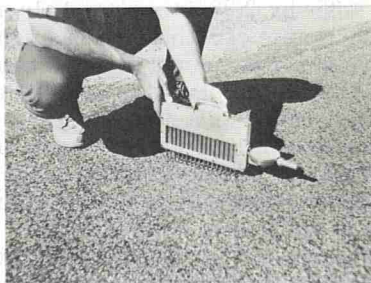
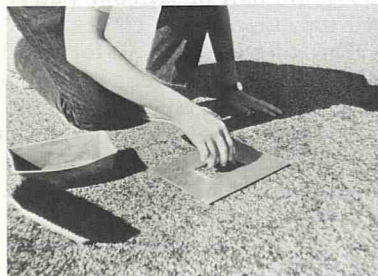
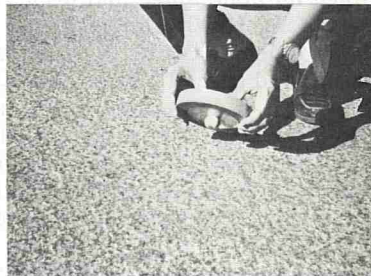
Figure 3. Equipment used for macrotexture tests.

Profilograph—The instrument used for this test was developed by the Texas Highway Department (15). It is designed to scribe a magnified profile of the surface texture as a probe is drawn across the surface. That is, the probe is placed on the pavement

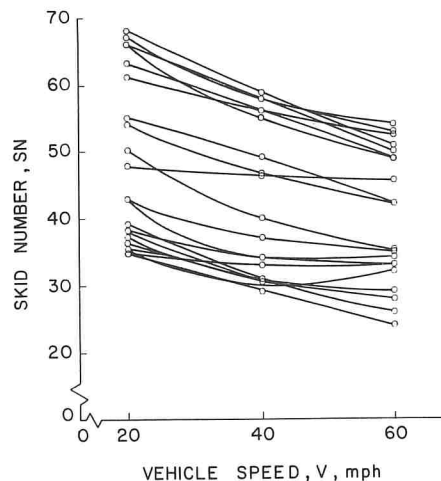
Figure 4. Skid number-speed relationships for hot-mix asphalt concrete surfaces.

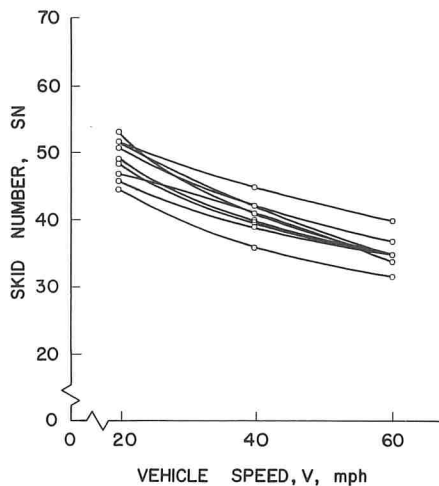
Figure 5. Skid number-speed relationships for portland cement concrete surfaces.

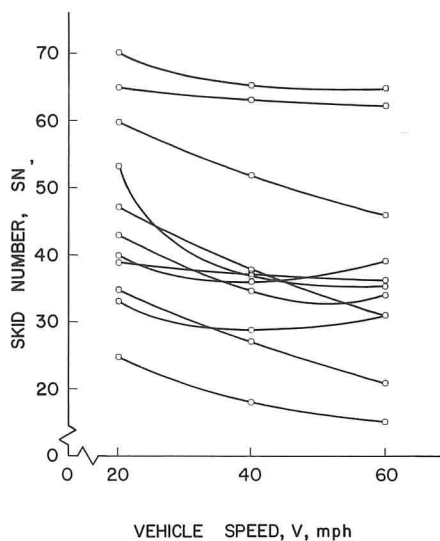
Figure 6. Skid number-speed relationships for surface treatments and seal coats.

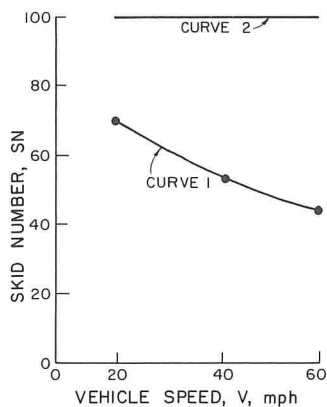
$$\text{AVERAGE SKID NUMBER } A_V SN = \frac{\text{AREA UNDER CURVE 1 (A}_1\text{)}}{\text{AREA UNDER CURVE 2 (A}_2\text{)}} \times 100$$

$$A_V SN_{20-60} \approx SN_{40}$$

Figure 7. Average skid number calculation.

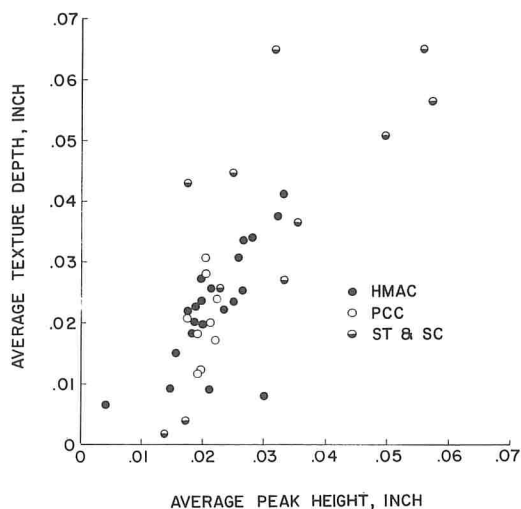
Figure 9. Putty impression versus profilograph methods.

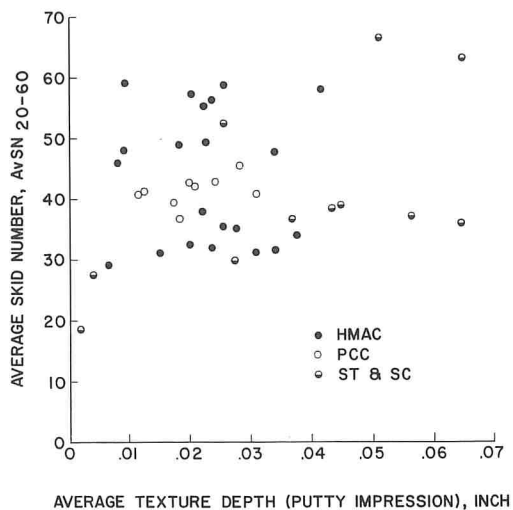
Figure 10. Average skid number versus macrotexture.

Statistical correlation of skid numbers with macrotexture measures obtained on the 41 surfaces are given in Table 5. Correlation coefficients were extremely low for all speed levels, but the relative magnitudes increased with higher speeds. Textures obtained with the profilograph consistently correlated better with skid numbers. A typical plot of one relationship is shown in Figure 10. A slight trend is noticeable.

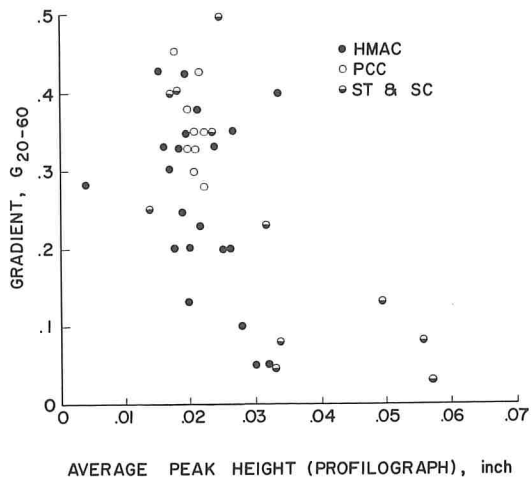
Figure 11. Gradient versus macrotexture.

Statistical correlation of friction-speed gradients obtained from 20-40 mph and from 20-60 mph with macrotexture measures obtained on the 41 surfaces are given in Table 6. Correlation coefficients were fairly low, particularly for the logarithmic relationships. Gradient computations from 20-60 mph resulted in higher coefficients than those from 20-40 mph. Also, the mechanical roughness detector instruments (profilograph and texturemeter) gave higher coefficients than the volumetric measures (putty and sand). A typical plot is shown in Figure 11.

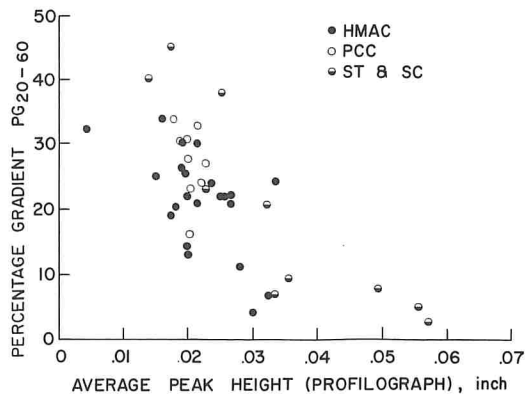
Figure 12. Percentage gradient versus macrotexture.

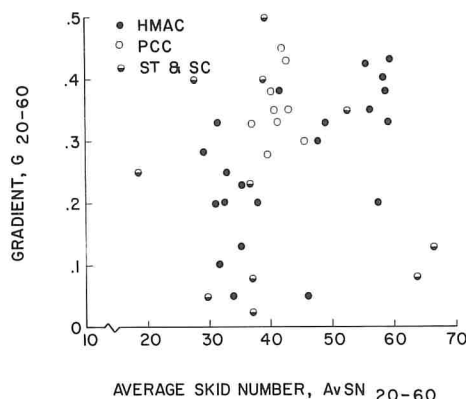
Figure 13. Gradient versus average skid number.
